Manhole Inspection Summary

Manhole # S67K__019MH

Insp Date: **2/8/08 10:52 AM**

Location Address: **6321 Hudson St.**

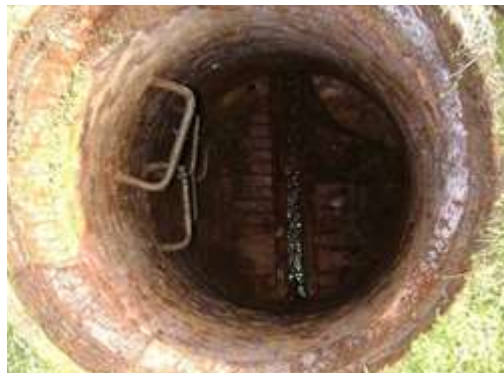
Top View

Condition: ☐ Sound ☒ **Cracked** ☐ Leaks

Infiltration: ☐ None ☒ **Joint** ☐ Cracks ☐ Mortar ☐ Roots ☐ Wall

☒ **Evidence Of Surcharge** Depth: **2** (ft.) ☐ Active Surcharge Present

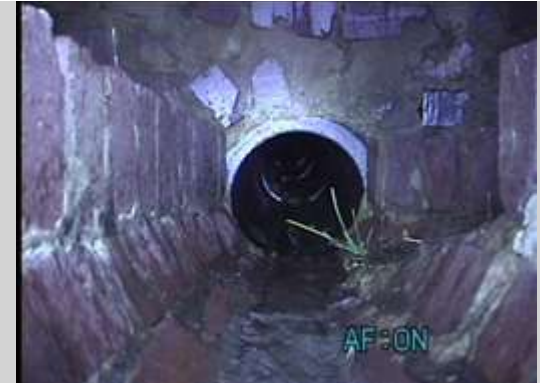
12 O'Clock Outflow

8 in. Circular Gravity Sewer
Pipe Out @ 12 O'Clock

Pipe Height: **8.4** (in.) Rod and Bar (Angled)
Pipe Material: **Clay** ☐ Pipe Lined
Invert Depth: **11.67** (ft.) Flow Characteristics: **Slow**
Deposits: ☒ None ☐ Mud ☐ Sludge ☐ Debris ☐ Grease
Silt Depth: (in.) Deposits Extent:
Infiltration: **None** Pipe Seal Cond: **Sound**

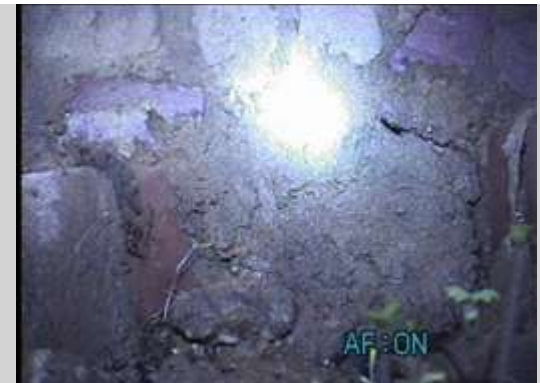
3 O'Clock Inflow

8 in. Circular Gravity Sewer
Pipe In @ 3 O'Clock

Pipe Height: (in.) Rod and Bar (Angled)
Pipe Material: **Clay** ☐ Pipe Lined
Invert Depth: **11.17** (ft.) Flow Characteristics: **None**
Deposits: ☒ None ☐ Mud ☐ Sludge ☐ Debris ☐ Grease
Silt Depth: (in.) Deposits Extent:
Infiltration: **None** Pipe Seal Cond: **Sound**

Connects To: **Stub connection / abandoned**

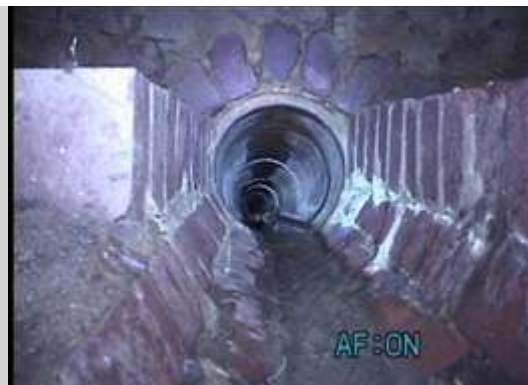
6 O'Clock Inflow

8 in. Circular Gravity Sewer

Pipe In @ 6 O'Clock

Pipe Height: **8.4** (in.) Rod and Bar (Angled)

Invert Depth: **11.17** (ft.) Flow Characteristics: **Slow**

Infiltration: **None** Pipe Seal Cond: **Sound**
